Manhole Inspection Summary

Manhole # S25I__052MH

Insp Date: **5/14/09 3:43 PM**

Location Address: **1100 W.Pratt St.** Cross Street: **100 Arlington St.**

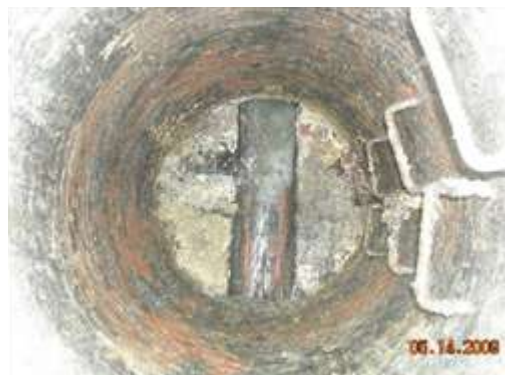
Top View

AFTER SPECIALTY CLEANING

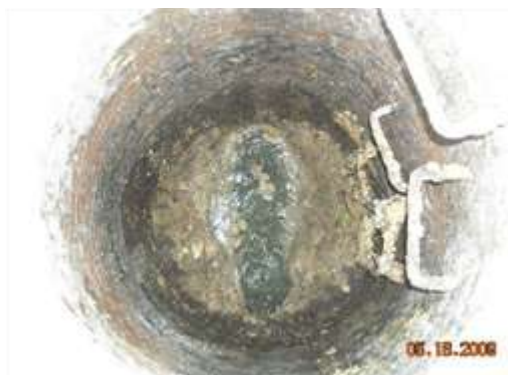
Miscellaneous

TOP VIEW PRIOR TO CLEANING

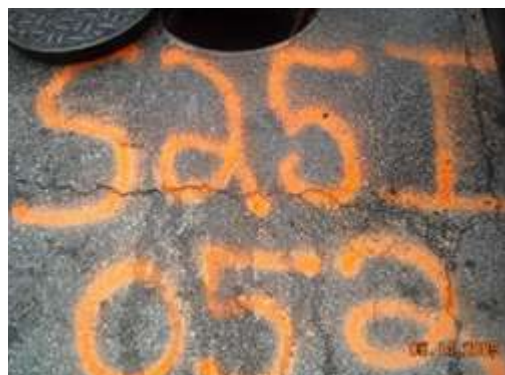
Miscellaneous

pavement markings

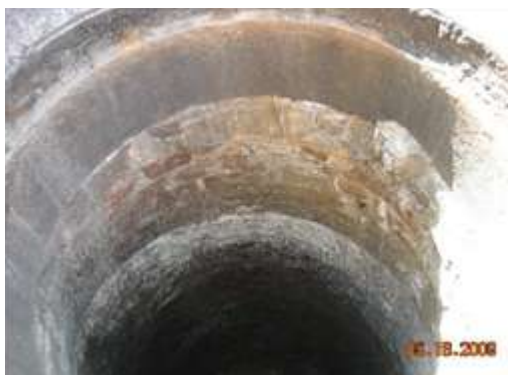
Defect 5

Frame Offset: **0** (in.) Condition: ☐ Sound ☐ Cracked ☒ **Leaks**

FRAME LEAKS

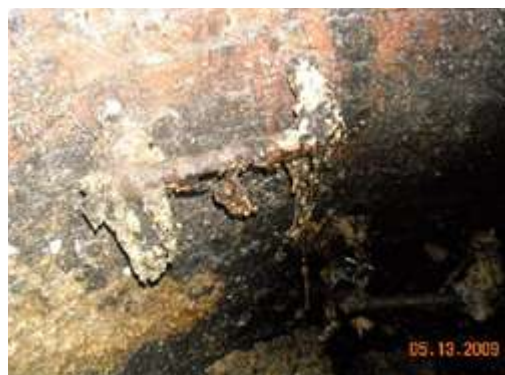
Defect 4

Steps Count: **6** Missing: **0** ☒ **Corroded**

Surcharge ☒ **Evidence Of Surcharge** Depth: **4** (ft.) ☐ Active Surcharge Present

Corroded Steps; Evidence of Surge

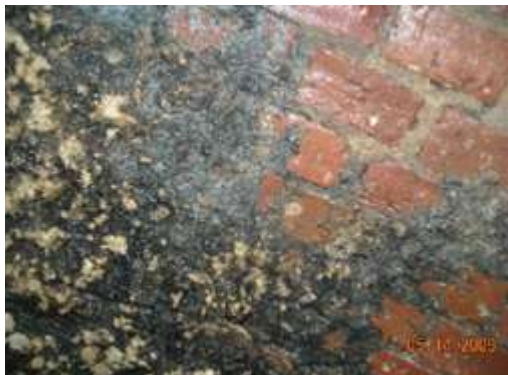
Defect 3

Barrel Material: **Brick** ☐ Parged
Shape: **Circular** Diameter: **48** (in.) Length: **0** (in.)
Condition: ☒ Sound ☐ Cracked ☐ Root Intrusion ☐ Loose Brick ☐ Deteriorated
Infiltration: ☐ None ☐ Joint ☐ Cracks ☒ **Mortar** ☐ Roots ☒ **Wall**

infiltration from barrel mortar & wall

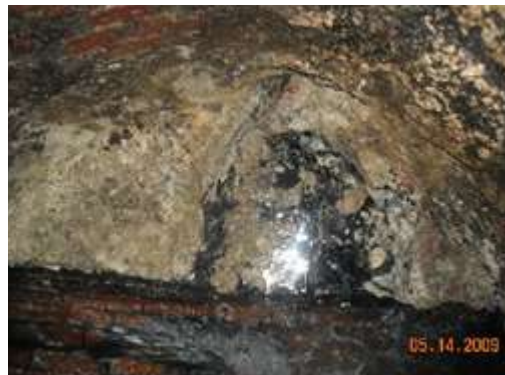
Defect 1

Bench ☒ Exists Material: **Brick** ☐ Parged
Condition: ☐ Sound ☐ Cracked ☐ Root Intrusion ☐ Deteriorated ☐ Leaks ☒ **Debris**

DEBRIS ON BENCH

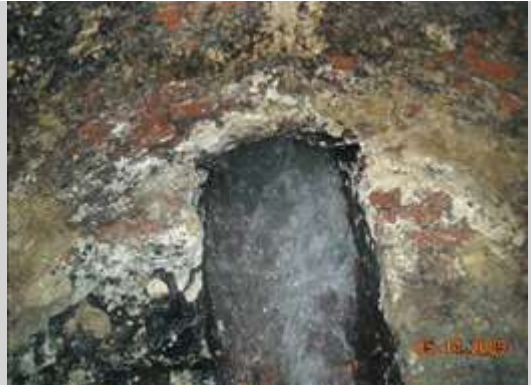
12 O'Clock Outflow

15 in. Circular Gravity Sewer
Pipe Out @ 12 O'Clock

Pipe Height: **10.8** (in.) Rod and Bar (Angled)
Pipe Material: **Clay** ☐ Pipe Lined
Invert Depth: **11.91** (ft.) Flow Characteristics: **Turbulent**
Deposits: ☐ None ☐ Mud ☐ Sludge ☐ Debris ☒ Grease
Silt Depth: **1** (in.) Deposits Extent: **Light**
Infiltration: **None** Pipe Seal Cond: **Sound**

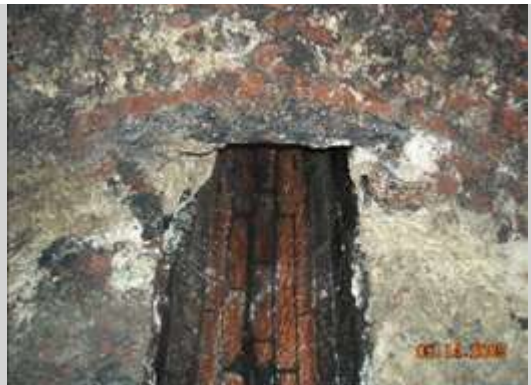
6 O'Clock Inflow

15 in. Circular Gravity Sewer
Pipe In @ 6 O'Clock

Pipe Height: **22.8** (in.) Rod and Bar (Angled)
Pipe Material: **Clay** ☐ Pipe Lined
Invert Depth: **11.71** (ft.) Flow Characteristics: **Fast**
Deposits: ☒ None ☐ Mud ☐ Sludge ☐ Debris ☐ Grease
Silt Depth: **0** (in.) Deposits Extent:
Infiltration: **None** Pipe Seal Cond: **Sound**
